VALUING SOCIETAL BENEFITS OF  
EARTHQUAKE ENGINEERING EXCELLENCE

NZSEE Annual Conference 2020  
22–24 APRIL 2020, WELLINGTON

# Unbonded post-tensioning of face loaded URM cavity walls under semi-cyclic and dynamic loading

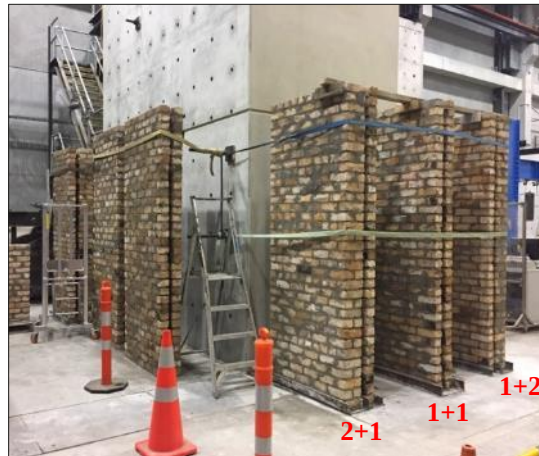
Five purpose-built full-scale URM wall specimens shown in Figure 1 were used for the experimental testing programme reported herein. The walls were one-way vertically spanning 3000 mm high and 1150 mm wide. The wall height was chosen to replicate a typical upper storey in a URM building. Two of the walls tested with a PT system were single-single cavity walls, denoted as "1+1", with a thickness of 275 mm and massed approximately 1430 kg. The other three walls were double-single cavity walls, denoted as "2+1", with a thickness of 395 mm and massed approximately 2150 kg. An approximately 55 mm wide air cavity separated

the wall specimens. These selected wall configurations are often found in New Zealand URM buildings, with the double-single cavity walls commonly but not exclusively found on lower floors. The cavity width in all the walls was specified as 55 mm, or approximately half the thickness of a standard brick.

*Figure 1: Wall specimens*
